# A Retained Guide Wire Following Hemodialysis Dialysis Catheter Insertion; Ultrasound Guided Localization and Retrieval: A Case Report

**Introduction:** Central venous catheterization with the use of Sheldinger technique is a commonly carried out procedure for hemodialysis, medication and monitoring. Migration of guide wire or retained guide wire is a rare and preventable complication of the procedure. This case report brings light on a case of retained guide wire following hemodialysis catheter insertion and its removal by using ultrasound for localisation of guide wire and thereby giving skin incision.

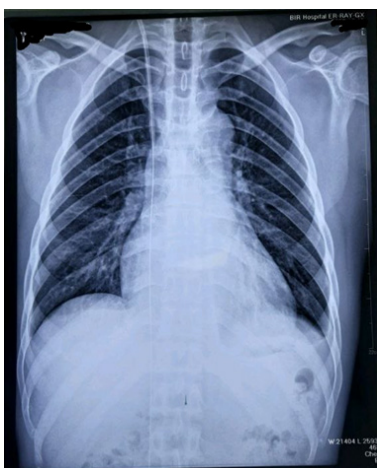
**Figure 1:** Chest X-ray showing retained guide wire

In this case, complete guide wire was lost into the circulation and was found in the right common iliac vein which was identified from chest x-ray and x-ray abdomen. We used realtime ultrasonography with a curvilinear probe to locate skin incision site and linear probe to locate the guide wire directly over the right common iliac vein to assist the surgeon for the removal of the retained guidewire. Use of CT scan, fluoroscopy and x-ray has been used mostly for removal of such retained guide wire but poses the risk of increased radiation exposure to the patient and healthcare

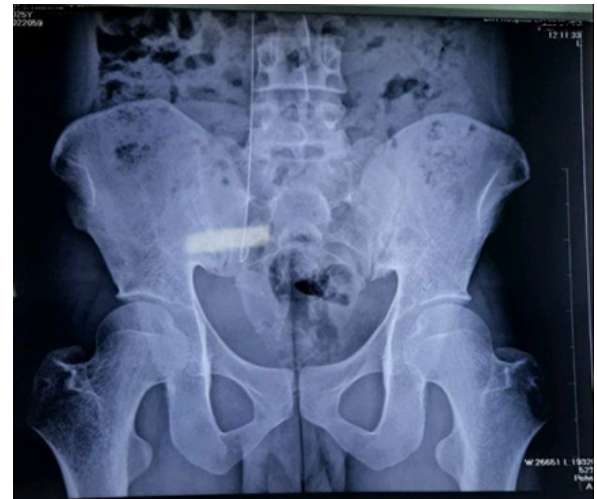
**Figure 2:** X-ray pelvis showing retained guide wire in common iliac vein

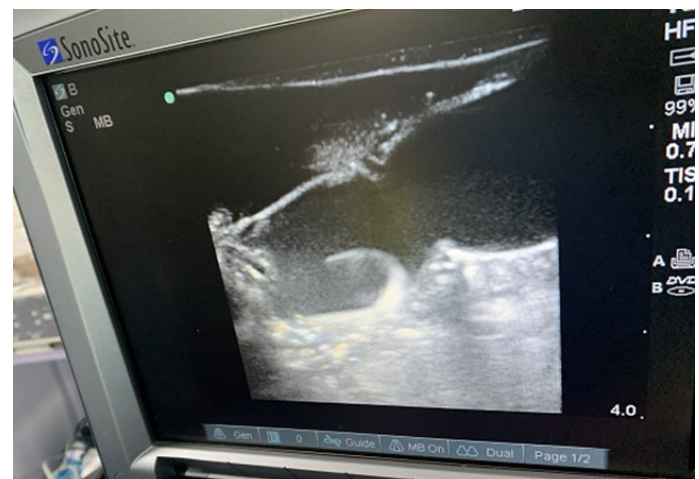
**Figure 3:** USG localising guide wire

Twenty five years old male with a history of Chronic Kidney Disease and hypertension, taking Amlodipine 10 mg, Torsemide 20 mg per orally since 2 months. He presented to the emergency department of Bir hospital complaining of shortness of breath and bilateral limb swelling for 6 days. There was no urine output for 8 days and he has a history of decreased urine output since 4 months. The patient was diagnosed with chronic kidney disease and hypertension 2 months back and started on medications as described earlier. There was no family history of kidney disease, hypertension, bleeding disorders. The patient was agitated, bilateral pitting edema on bilateral lower limbs, pallor, heart rate 96 bpm, blood pressure 150/90 mmHg and respiratory rate 24 breaths/min was noted during general examination. Bilateral decreased air entry present in bilateral basal areas of lungs and other systemic examinations were within normal limits. His hemoglobin was 8.3 gm/dl, urea 357 mg/dl, creatinine 21 mg/dl, chest xray showed bilateral pleural effusions and other investigations were within normal limit. The patient was then advised for urgent renal replacement therapy and 12 Fr double lumen dialysis catheters were inserted in the right internal jugular vein under USG guidance via Seldinger technique. Emergency dialysis was done for 2 hours with ultrafiltrate of 2000 ml which improved the patient's symptoms. On the next morning, Chest x-ray was done which visualized that the guide wire of dialysis catheter was in-situ tracking through inferior vena cava which was neglected and retained (Figure 1). Further x-ray pelvis revealed the J shaped end of the guide wire located at the right common iliac vein at the level of 3rd sacral vertebrae (Figure 2). USG abdomen and pelvis visualized linear echogenic structure in inferior vena cava and right common iliac vein with no obstruction consistent with guide wire inserted (Figure 3).

Dialysis catheter guide wire was located using ultrasound curvilinear probe 8-3 MHz (SonoSite X-Porte, C35xp probe) and marked. Skin incision was given in the right inguinal region. Right common iliac vein was visualized which was then submerged with normal saline and ultrasonography was done using linear probe 13-6 MHz (SonoSite X-Porte, HFL38xp probe) using sterile technique and incision site was marked just above right common iliac vein. With the help of intraoperative USG through the incision site, j-shaped end of the tip guide wire was located (Figure 4,5). Incision was given over the right common iliac vein after applying vascular clamp proximal and distal to the incision site. Dialysis catheter guide wire was removed successfully. On measurement it was 40 cm long (Figure 6).

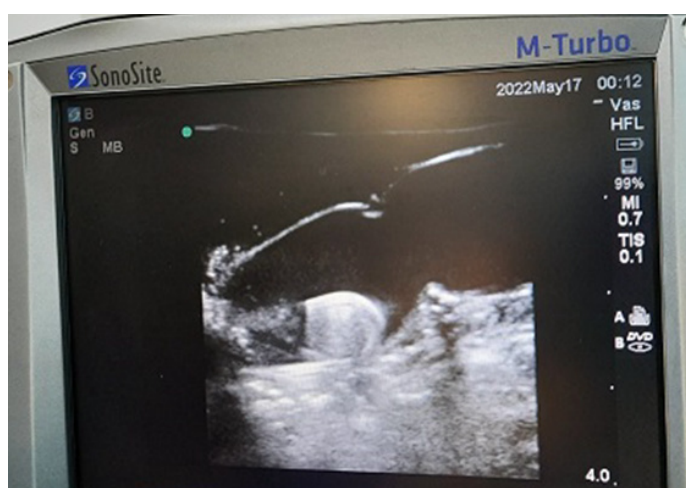
**Figure 4:** Intraoperative localisation of guide wire

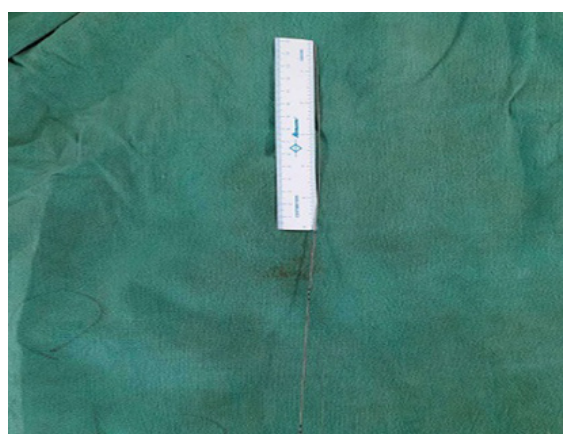
**Figure 6:** Removed guide wire
